INDIANA DAM SAFETY INSPECTION MANUAL

PART 3

DAM SAFETY INSPECTIONS

Part 3, this part, provides guidance on evaluating dam safety and performing dam inspections. It covers who should perform the inspections and how, and provides guidance on identifying and reporting dam deficiencies and problems.

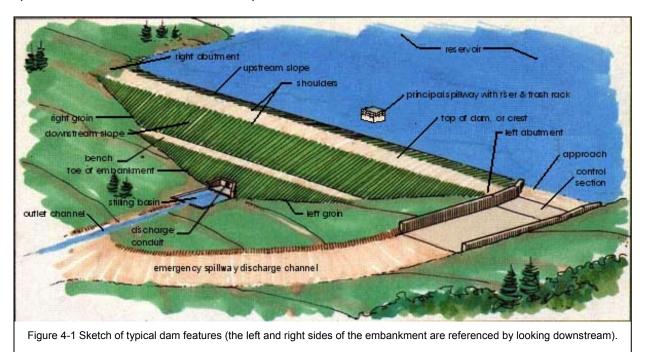
Figure 4-1 shows typical features that require inspection and are common on embankment dams. Dam features and descriptions should be referenced "looking downstream." For example, with the inspector standing on the embankment crest and looking downstream, the abutment on his/her right is the right abutment; the abutment on his/her left is the left abutment. Concrete dams may have similar features except they do not have an earthen embankment. Other features that are common at dams but are not shown include rock toe drains with piping, cutoff trenches, and riprap groin areas.

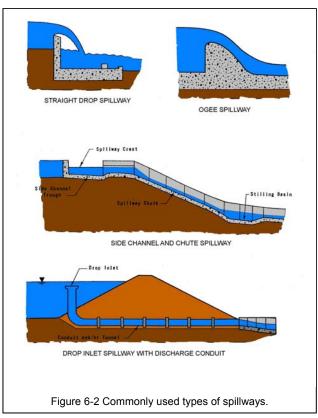
Drop Inlet Spillway (also called Morning Glory Spillway, or Shaft Spillway) - A vertical or inclined shaft into which flood water spills and then is conducted through, under, or around a dam by means of a conduit or tunnel. If the upper part of the shaft is splayed out and terminates in a circular horizontal weir, it is termed a "bellmouth" or "morning glory" spillway. The vertical portion of the spillway is called the **riser**. The risers

are typically reinforced concrete pipes or boxes. Shaft spillways are commonly used in Indiana as the principal spillway, and are usually referred to as drop inlets or risers.

The following types of spillways are commonly found at dams; however, many variations of these spillways may be used. Figure 6-2 illustrates some commonly used types of spillways. The most commonly used spillways used in Indiana include the drop inlet (or shaft) spillway used as the principal spillway, and an open channel used as an auxiliary, or emergency spillway.

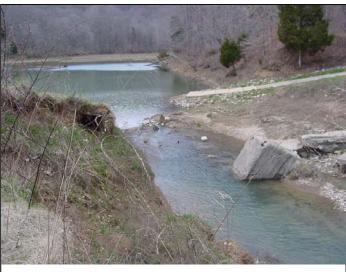
Figure 6-5 This dam's open channel spillway used a concrete control section; note that it failed and was almost totally washed away.

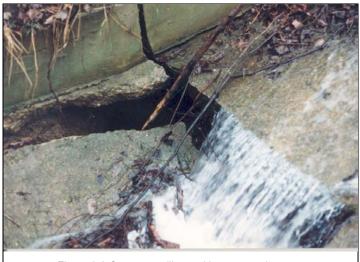
Figure 6-8 Concrete spillway with structure damage.

Misalignment and displacement of spillway walls and chute slabs are often associated with large cracks. These cracks may be caused by foundation settlement. uneven foundation erosion. displacement, or excessive earth or water pressure. Large cracks will allow water to wash out the materials below or behind the concrete slab, causing erosion and leading to more cracks. Extensive cracking can cause the concrete slab to be severely displaced, dislodged, or washed away by the When large cracks are flow.

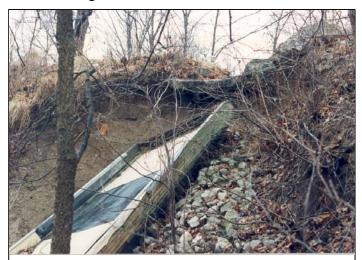
Figure 6-13 This concrete spillway was completely destroyed as a result of foundation erosion.

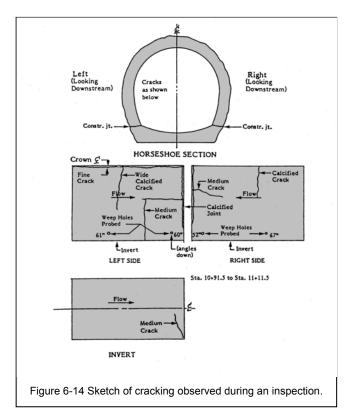
A crack survey should identify characteristics of the cracks such as, length, width, direction, trend, depth, offset, and location. It should also describe the cracks based on the definitions presented above.

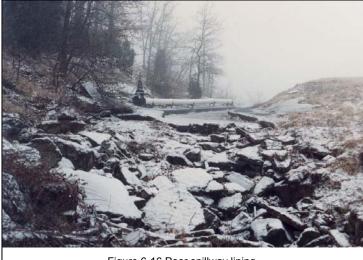
Figure 6-16 Poor spillway lining.

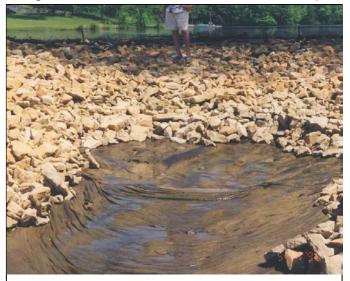
Figure 6-17 Riprap lining was completely washed away during a significant storm event, exposing the geotextile filter.

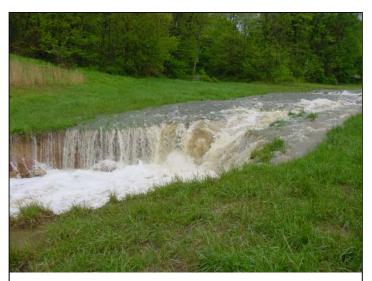
Figure 6-19 Grass lined outlet channel that was not designed for the flows it experienced, resulting in severe erosion.

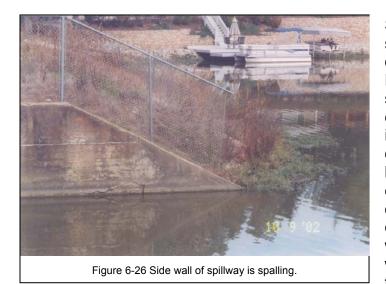
Spalling usually affects only the surface of the structure, so it is not ordinarily considered dangerous. However, if allowed to continue, spalling will structural cause damage, particularly if the structure is of thin cross section. Spalling often results in exposed reinforcing, paths opened around leakage embedded waterstops at joints, offsets on flow surfaces. development of points of structural Repair is necessary weakness. when reinforcing becomes exposed to the elements. The method of

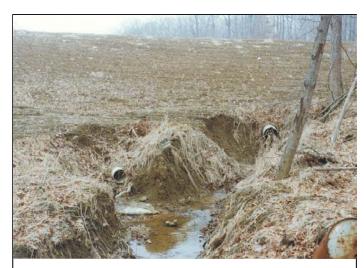
Figure 6-36 Severe erosion in earth outlet channel adds sediment to receiving stream.

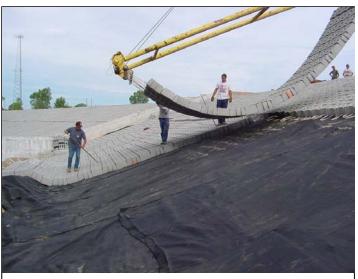
Figure 6-41 Articulating blocks are being placed over a geotextile filter on a dam embankment.

Geotextiles are water permeable, generally made polypropylene or polyester, and can woven. nonwoven, or а combination of woven and nonwoven segments. Uses for geotextiles include separation between materials. layers of drainage, reinforcement. and filtration. In dams, geotextiles may temporary or permanent construction uses. Geotextiles placed as embankment dam core and foundation filters would be

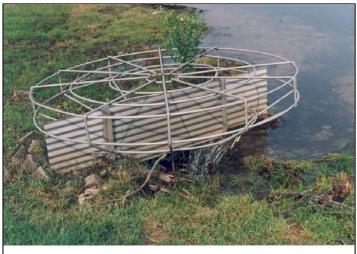
Figure 6-48 Poorly constructed trash rack has openings that are too large at the riser crest.

A well-designed trash rack will stop large debris that could plug the discharge pipe but allow unrestricted passage of water and smaller debris. Some of the most effective racks allow flow to pass beneath the trash into the riser inlet as the pool level rises. Racks usually become plugged because the openings are too small, or the head loss at the rack causes material and sediment to settle out and accumulate. Small openings will stop small debris such as twigs and leaves, which in turn cause a progression of larger items to build

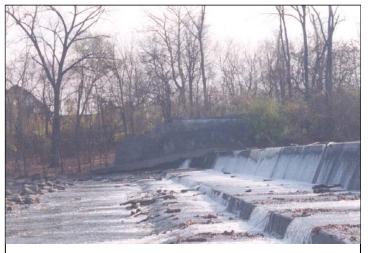
Figure 7-2 Most concrete dams in Indiana are in-channel structures that are difficult to inspect.

difficult to inspect because they are continuously inundated with overflow, and typically have a lot of debris on the structure (see Figures 7-2 and 7-3). Sometimes these concrete structures are contained in or along earth embankments.

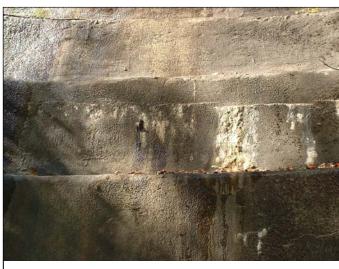
Figure 7-11 Calcium carbonate deposits on the downstream face of a concrete dam as a result of water seepage.

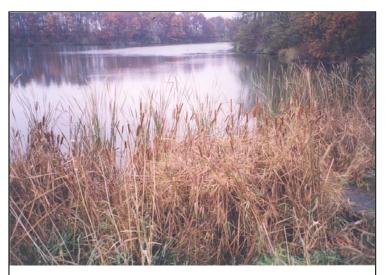
Figure 8-4 Excessive vegetation in reservoir almost completely conceals the spillway riser.

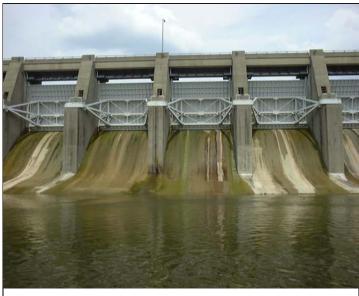
Figure 8-5 Downstream view of gates on a central-Indiana dam.

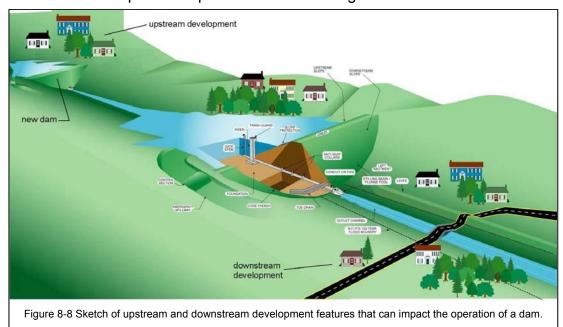
Downstream channel obstructions, including dams, can have an impact on the discharge from the dam if the new facilities are close enough. Tailwater that backs up from dams and other obstructions during floods, may reduce the discharge capacity of the upstream dam, especially if the upstream dam has a conduit spillway. The hydrologic and hydraulic calculations for the new features, if performed, should take the upstream dam into account. Tailwater from obstructions should be carefully evaluated to determine if it will impact the upstream dam discharge structures.
